# A Failure of Imagination

Roofing, the Canadian Electrical Code, and why the status quo isn't working anymore

Fall 2022

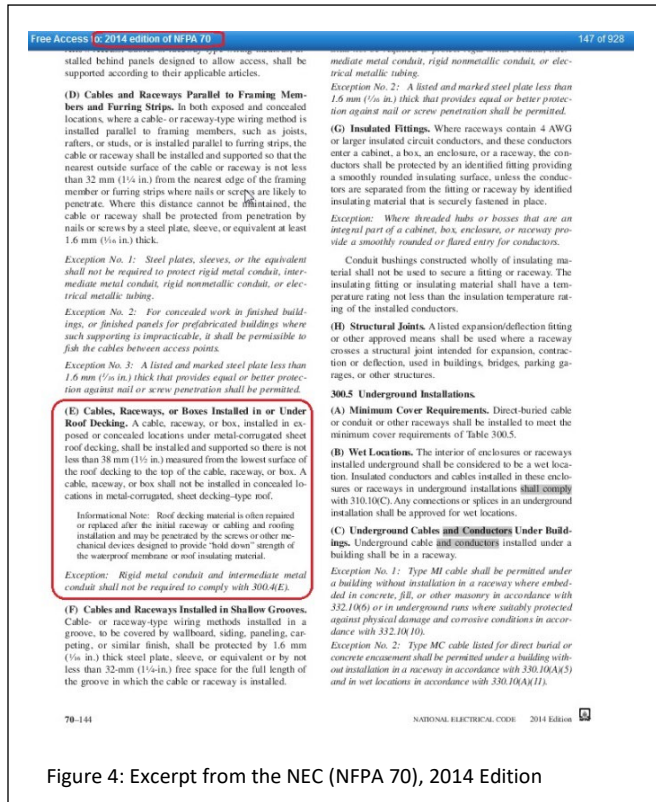
Figure 4: Excerpt from the NEC (NFPA 70), 2014 Edition

Since 2008, the NEC has amended Rule 300.4(E) to include the prohibition of electrical boxes (2011) installed directly beneath the roof deck (Figure 4). A further proposed change to include the prohibition of luminaires (light fixtures) directly beneath the roof deck was on the books for the 2017 NEC but evidently did not receive approval.

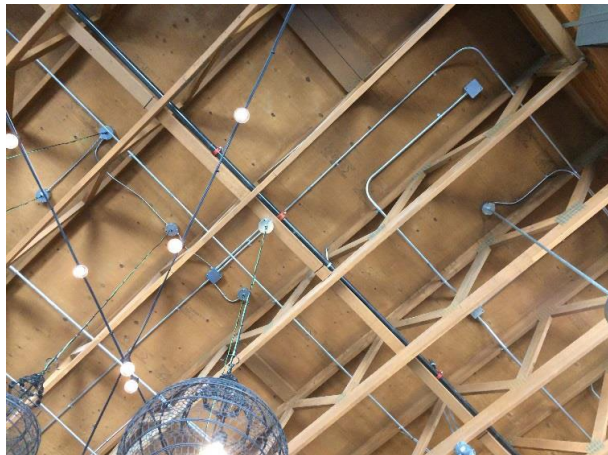
Figure 6: Junction boxes and conduit installed directly to the underside of a plywood roof deck. (Photograph by the author)
