# A Failure of Imagination

Roofing, the Canadian Electrical Code, and  
why the status quo isn't working anymore

November 2022

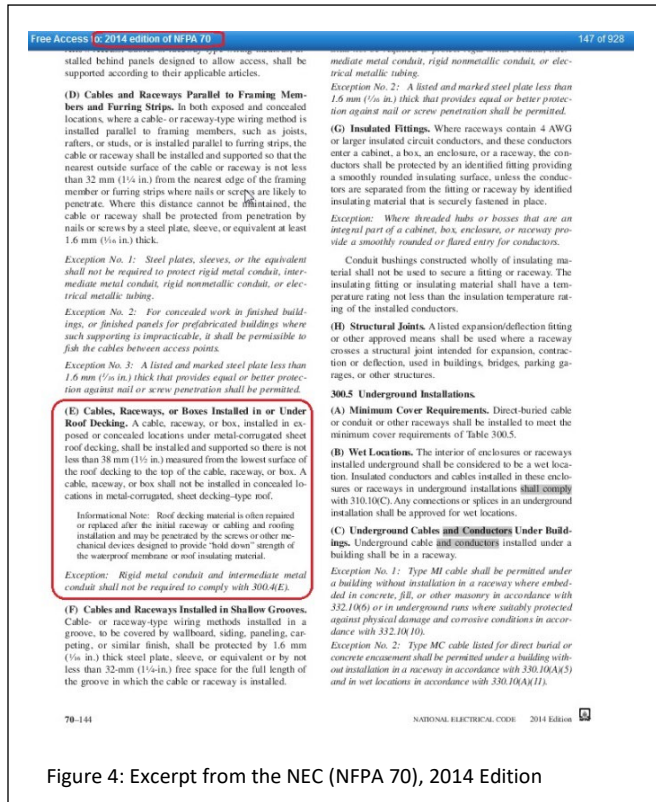
Figure 4: Excerpt from the NEC (NFPA 70), 2014 Edition

Since 2008, the NEC has amended Rule 300.4(E) to include the prohibition of electrical boxes (2011) installed directly beneath the roof deck (Figure 4). A further proposed change to include the prohibition of luminaires (light fixtures) directly beneath the roof deck was on the books for the 2017 NEC but evidently did not receive approval.
